INDOOR AIR QUALITY ASSESSMENT

**Frank H. Freedman Elementary School
90 Cherokee Drive
Springfield, Massachusetts**

Prepared by:
Massachusetts Department of Public Health
Bureau of Environmental Health Assessment
January, 2002

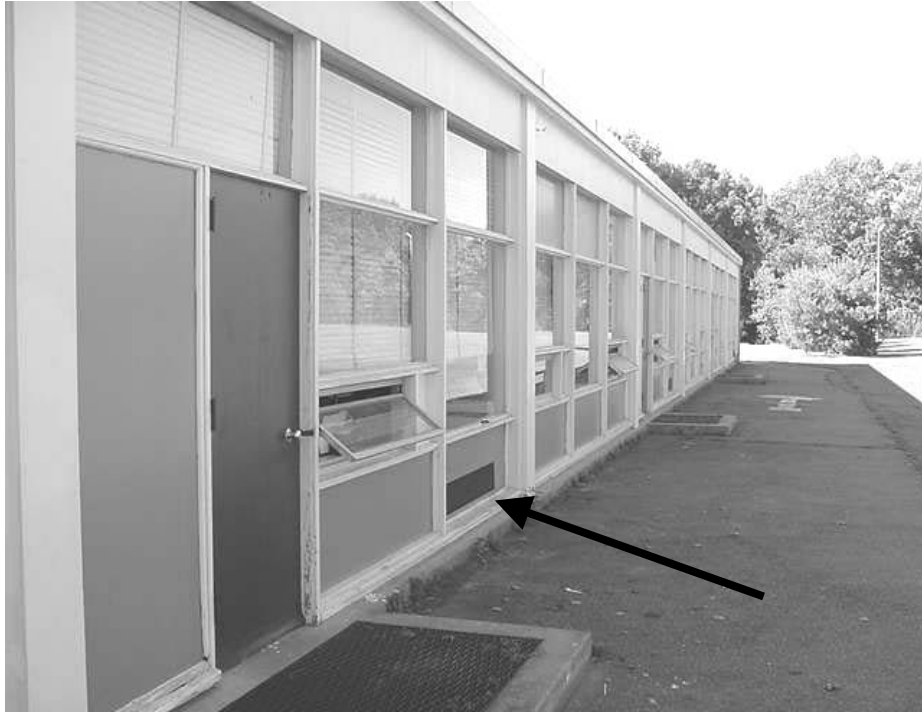
Picture 1

Fresh air in classrooms is supplied by a mechanical unit ventilator (univent) system. Univents draw air from outdoors through a fresh air intake located on the exterior walls of the building (see Picture 1) and return air through an air intake located at the base of each unit. The mixture of fresh and return air is drawn through a filter and a heating coil, and is then expelled from the univent by motorized fans through fresh air diffusers (see [Figure 1](#)). Univents were operating in all but three classrooms surveyed during the assessment. Obstructions to airflow, such as objects stored on or in front of univents, were observed in a number of classrooms. In order for univents to function as designed, fresh air diffusers and return vents must be unblocked and remain free of obstructions. Importantly, these units must be activated and allowed to operate during classroom occupation.

Univent Fresh Air Intake

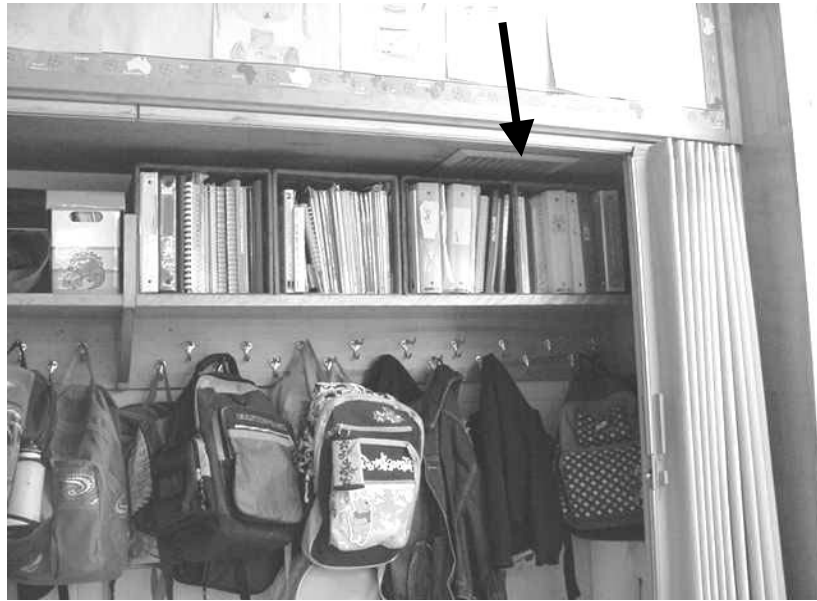
Picture 2

Exhaust ventilation is provided by a mechanical exhaust system. The exhaust vents are located in the upper portions of coat closets in classrooms. Classroom air is drawn through a space beneath the closet door and exits via the exhaust vent at the top of

the closet (see Picture 2). This design allows for the vents to be easily blocked by stored materials on shelves beneath the exhaust vent. In a number of classrooms, vents were blocked with boxes, cartons, books and other obstructions.

Exhaust Vent at the Top of the Closet

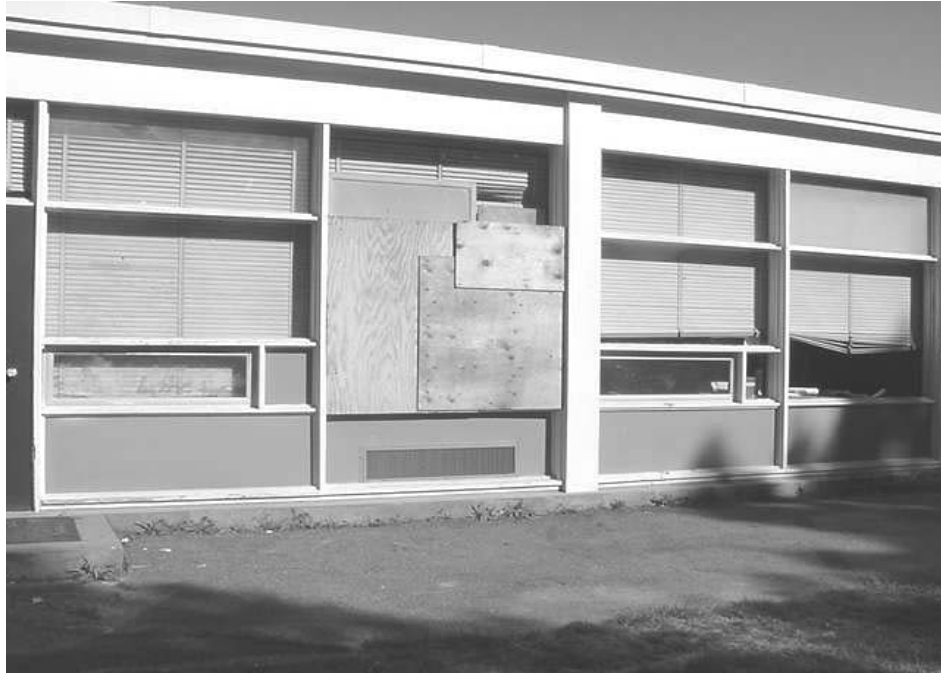
Picture 3

The exterior wall system of the building consists of wooden frames that hold paneling, door and window frames (see Picture 3). In a number of areas, this frame system had peeling or eroded paint and panel sealant, which can allow for moisture to penetrate the wood during wet weather. These conditions appear to have caused some of these frames to rot on the southern wall of the building. In one instance, damage to the framing system has resulted in a section of exterior wall cladding to slide from its

The Exterior Wall System of the Building Consists of Wooden Frames, Note Plywood

1. Consideration should be given to repairing or replacing the exterior wall system where the frames are materially degraded.
2. Repair leaks in the univent joints to prevent moisture build-up. Repairs may include replacing heat system components.
3. Removed damaged window caulking and reseal windows.

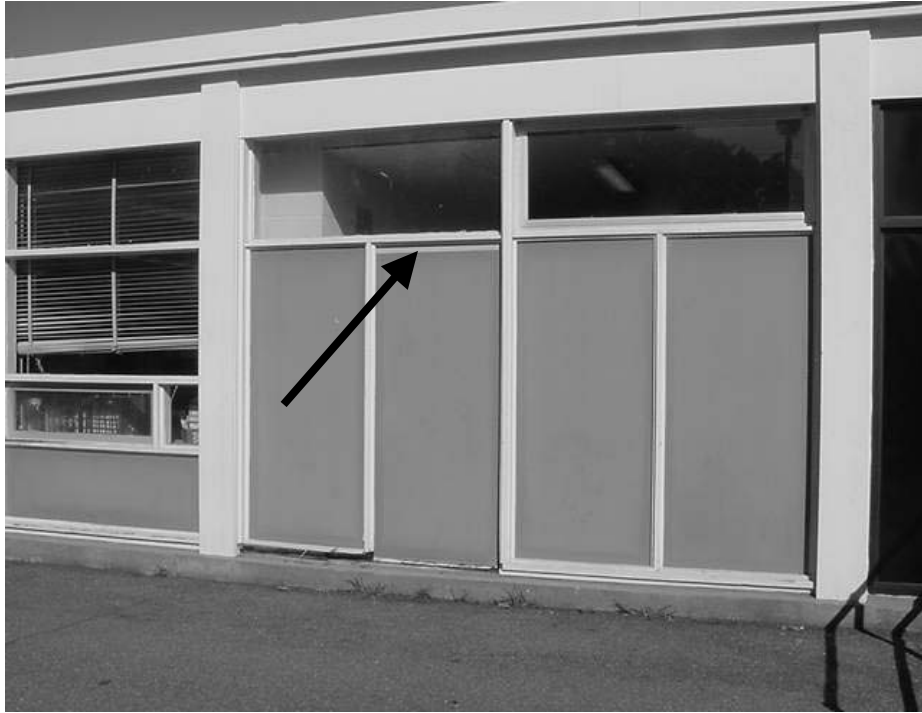
Picture 4

mooring (see Pictures 4 and 4A). If water is saturating the frame material, water penetration into the interior wall cavity is likely through panel/frame seams (see Picture 5). Another source of water penetration through the exterior wall system is exterior doors. Water damage around doorframes was observed in a number of classrooms. Water penetrating into the wall cavities can serve to moisten building materials or debris, which can then lead to microbial growth in the wall cavity.

Damage to the Framing System Has Resulted In One Section of Exterior Wall Cladding to Slide From Its Mooring

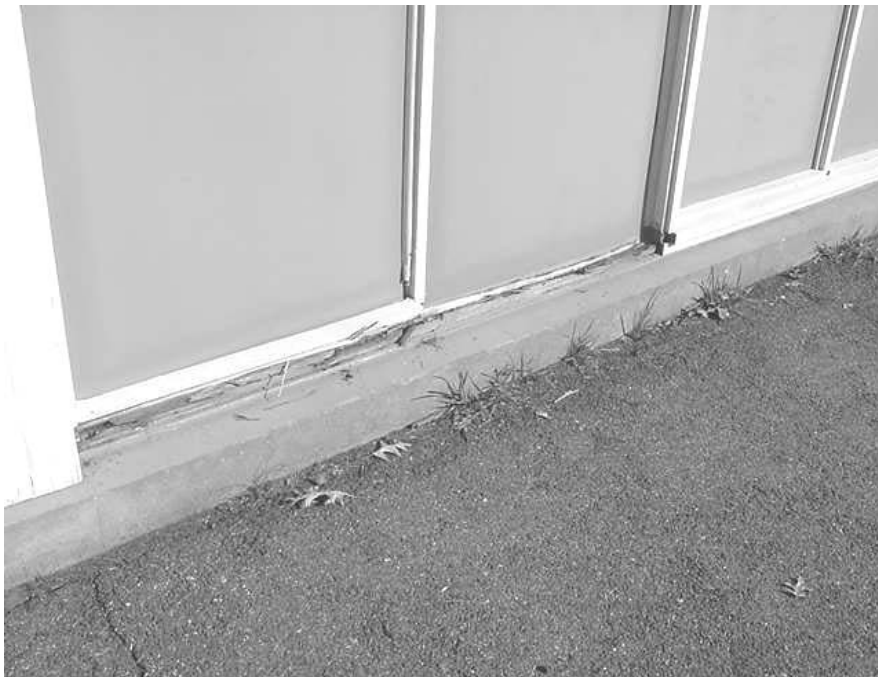
Picture 4A

Base Of Sliding Panel in Picture 4, Note Decayed/Missing Frame at Base of Panel

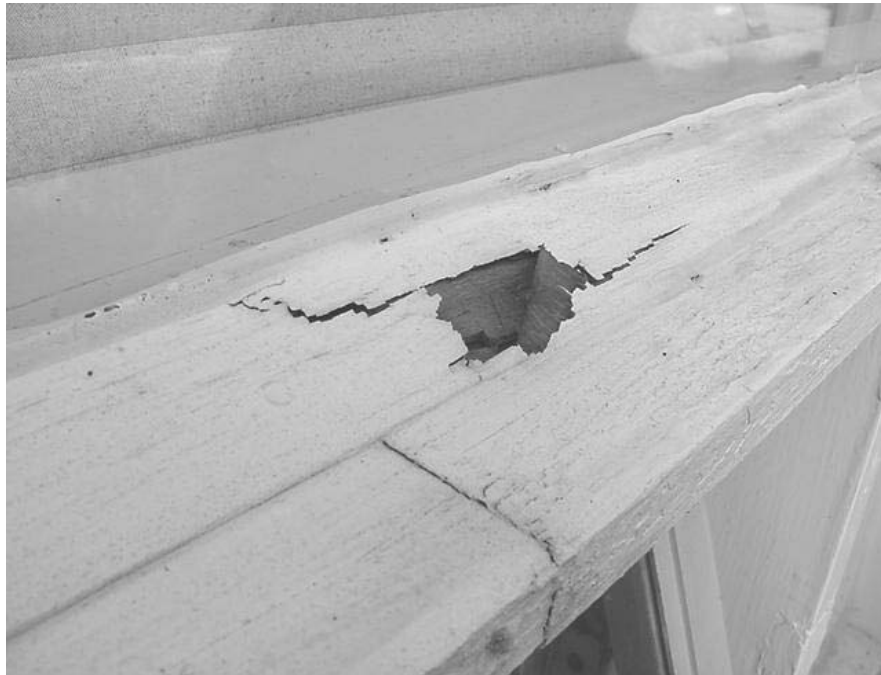
Picture 5

Damaged Window Frame

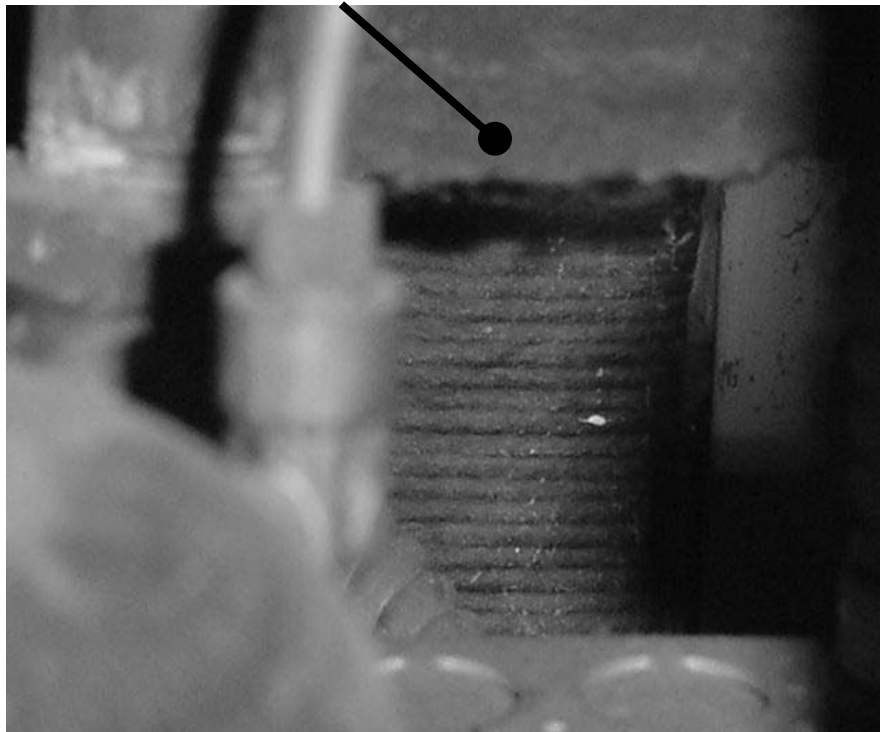
Picture 6

The interior of several univents was examined. As univent motors operate, the fan chamber depressurizes, which draws air from the classroom into the cabinet through the return vent. If holes exist in the fan chamber, air may also be drawn from the chambers containing univent controls and utility pipes. If holes into the exterior wall cavity exist in the controls and utility pipe chambers, then air debris can be drawn into the fans and distributed into classrooms. Each univent examined had holes in the fan chamber walls as well as opening into the exterior wall cavity (see Picture 6) from the controls and utility pipe chambers. In this condition, air and pollutants can be drawn into univent fans and distributed into classrooms.

Univent Cabinet Back Wall

Hole In Back of Univent Open to the Exterior Wall Cavity

2. Render holes in the fan cabinets airtight with a sealant compound.
3. Seal holes inside univents with rigid foil faced sheet material and water based high temperature and fiber reinforced mastic. Temporarily sealing the holes in this manner would prevent both air and moisture penetration into univents.

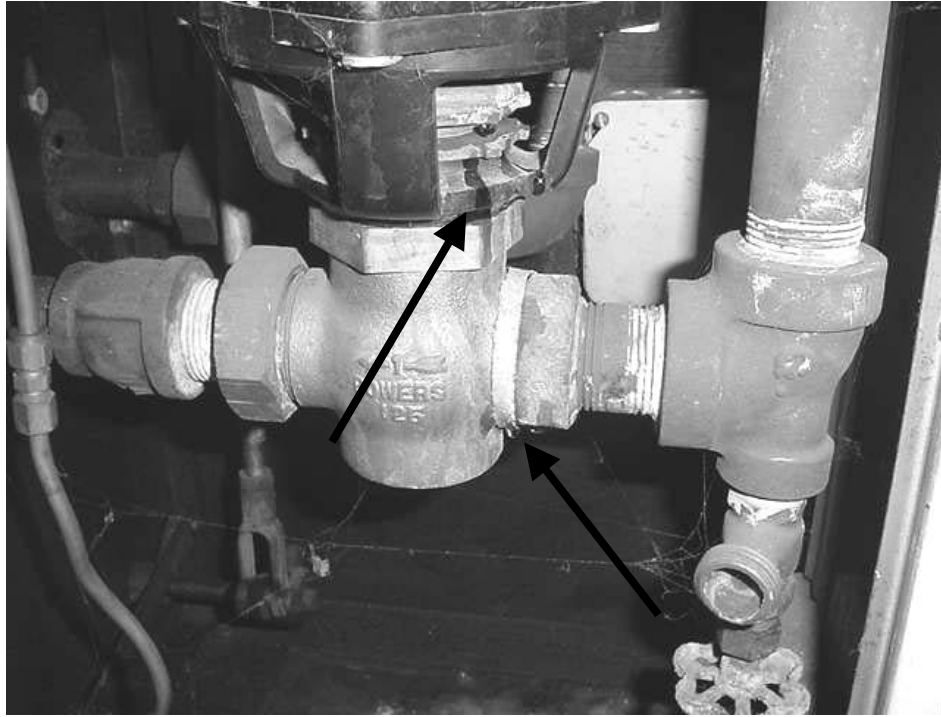
Picture 7

A potential source of microbial growth exists within the univent controls and utility pipe chambers. An active water leak was noted in pipes for a univent (see Picture 7), which then dripped onto the floor of the cabinet. Univent controls and utility pipe chambers examined had a heavy coating of dust, dirt and other debris. In one univent, water spattering on the floor of the univent utility pipe chamber formed a distinct pattern (see Picture 8). Moisture combined with accumulated debris can provide a medium for microbial growth. If microbial growth occurs, spores and other related materials can then be drawn into univent fans.

Active Water Leak Was Noted In Pipes for A Univent

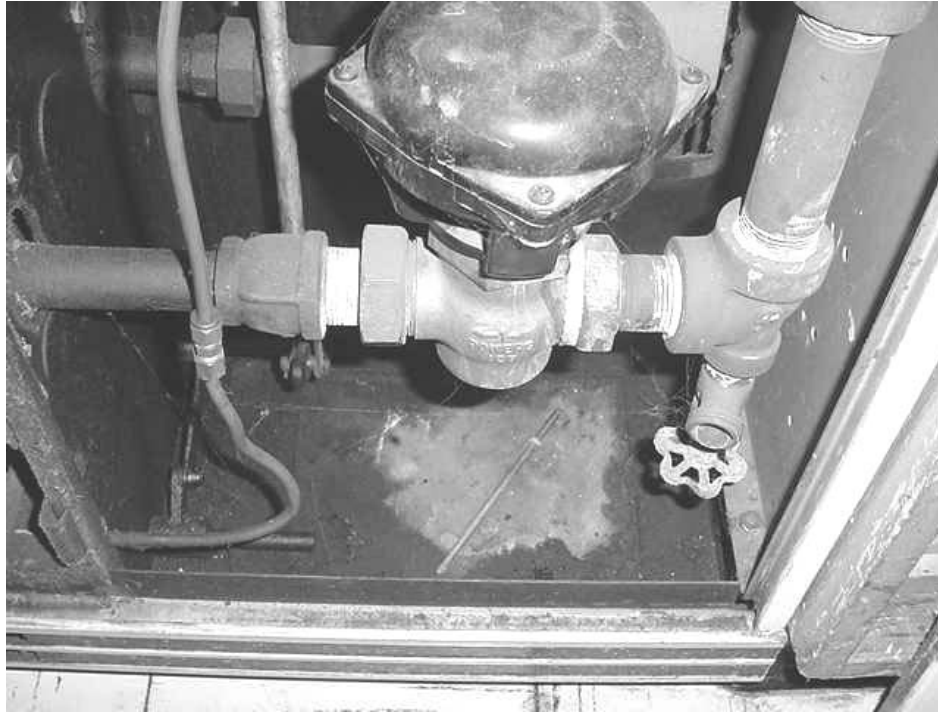
Picture 8

**Pattern Formed In Accumulated Materials on Floor of Univent
Chambers by Dripping Water from Heating System**

4. Clean accumulated debris from the interior of all univents.
5. Survey classrooms for univent function to ascertain if an adequate air supply exists for each room and make univent repairs as needed. Check fresh air intakes for repair and increase the percentage of fresh air intake if necessary. Consider consulting a heating, ventilation and air conditioning (HVAC) engineer concerning the calibration of univent fresh air control dampers school-wide.

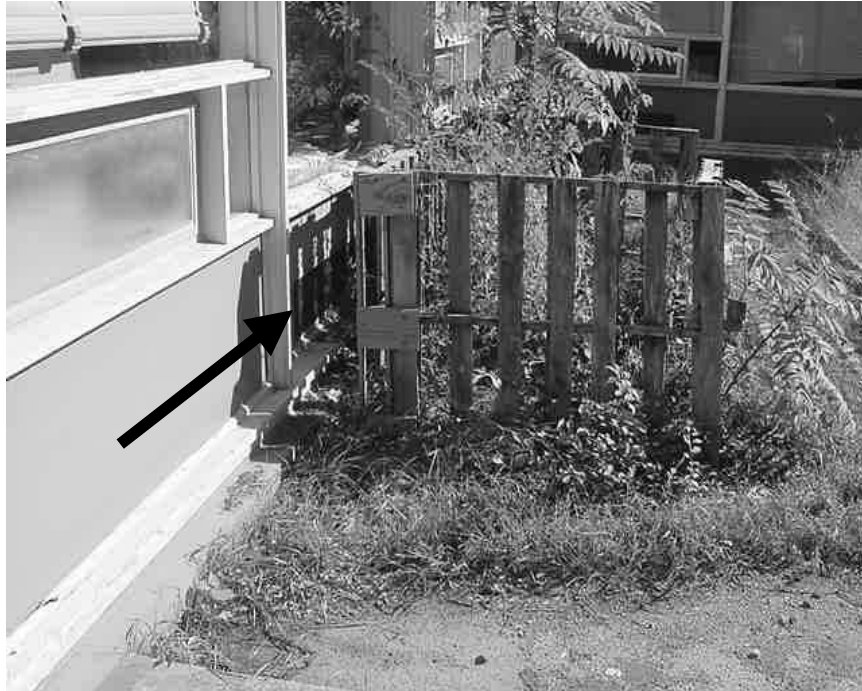
Picture 9

Located outside room 13 is a compost heap (Picture 9). This pile of debris is located in close proximity to the univent fresh air intake for this classroom. Composting is a controlled degradation of organic material by microorganism (US EPA, 1991). These microorganisms may include both bacteria and fungi. Microorganisms in the compost pile may be drawn into the univent and then distributed into this classroom.

Compost Heap outside Room 13, Note Univent Fresh Air Intake

1. Remove the compost pile from close proximity to the fresh air intake. Removal should occur after school hours. Temporarily seal the fresh air intake with polyethylene plastic to prevent contamination during the removal.
